MTMC REPORT OA 7T-16

**AN ANALYSIS
OF MTMC PARTICIPATION
IN THE
REFORGER 76 EXERCISE**

MARCH 1977

**MILITARY TRAFFIC MANAGEMENT COMMAND
TRANSPORTATION ENGINEERING AGENCY
NEWPORT NEWS, VIRGINIA 23606**

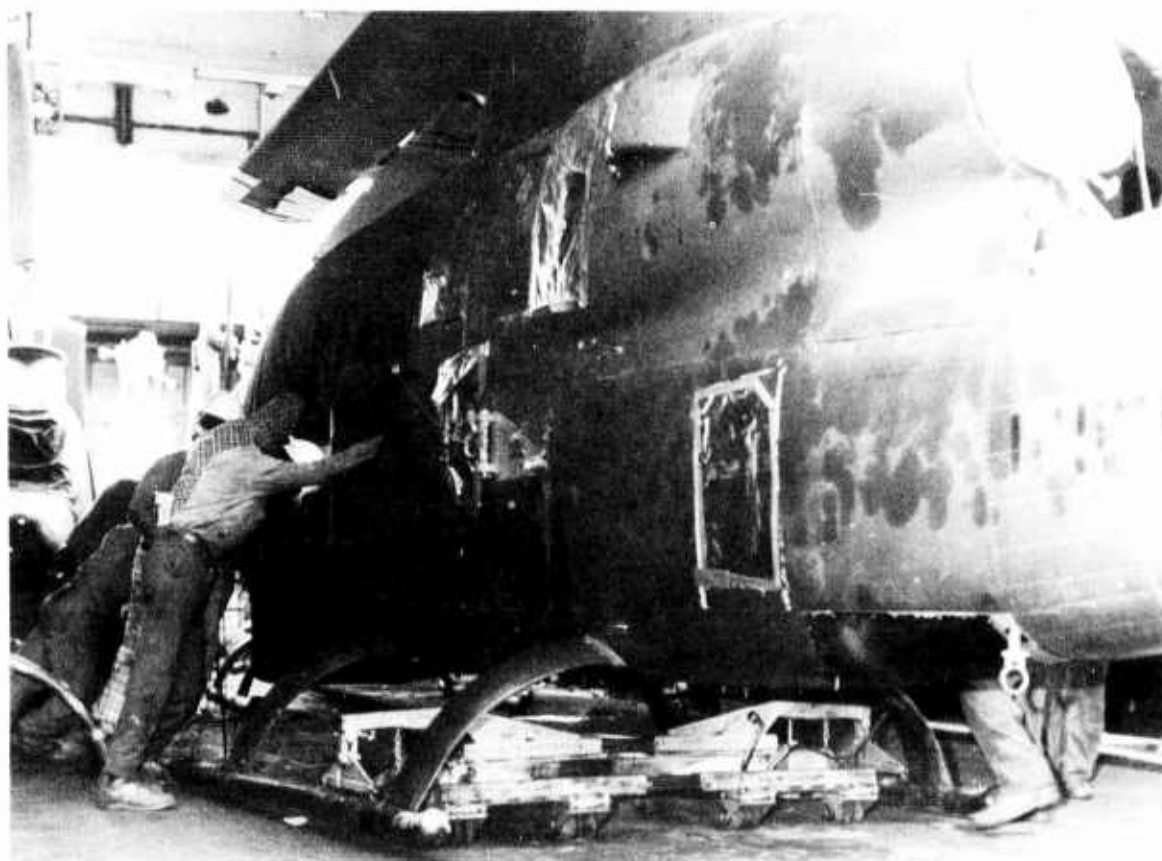
Figure 8-8. Helicopter Positioning Device (MTMC Device).

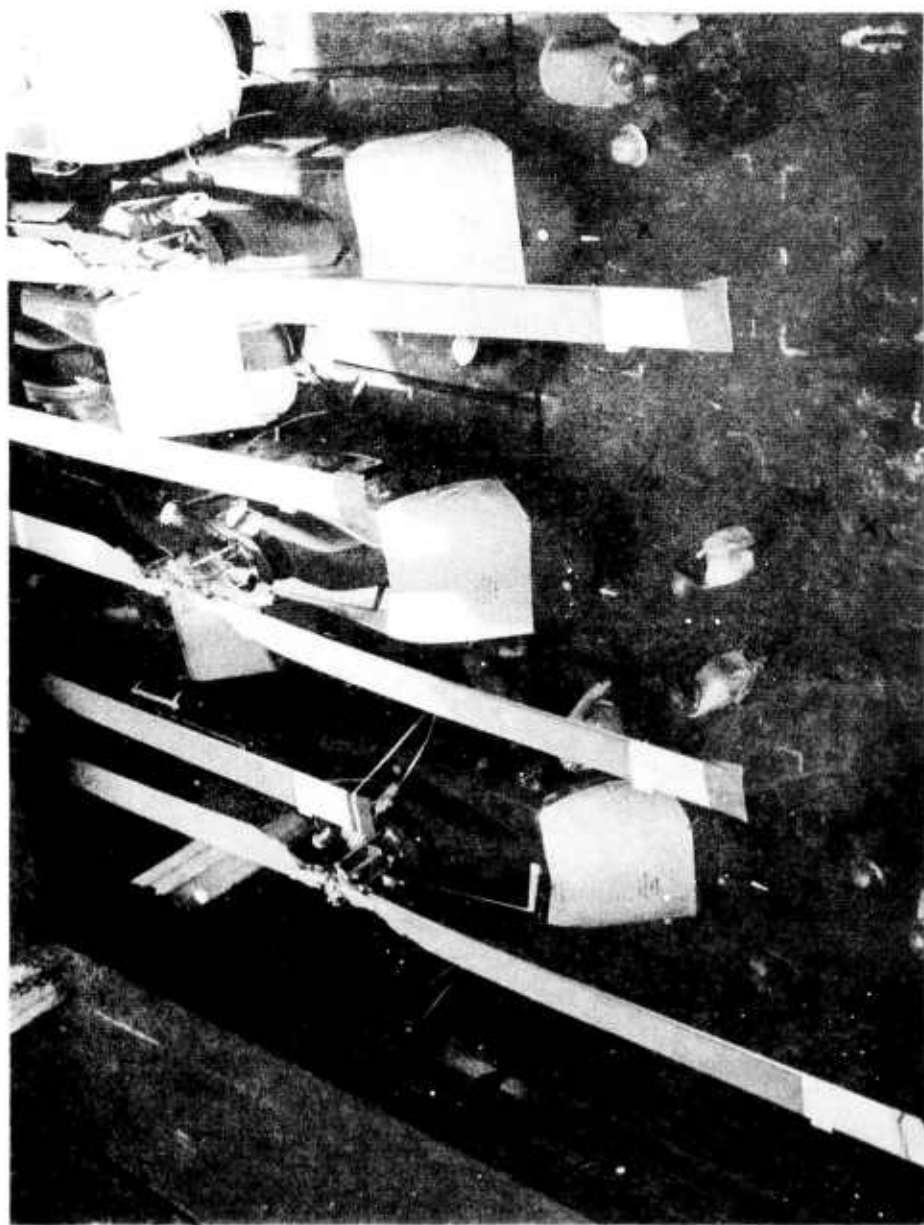
Figure 8-9. Typical Tight Helicopter Stow (OH-58).

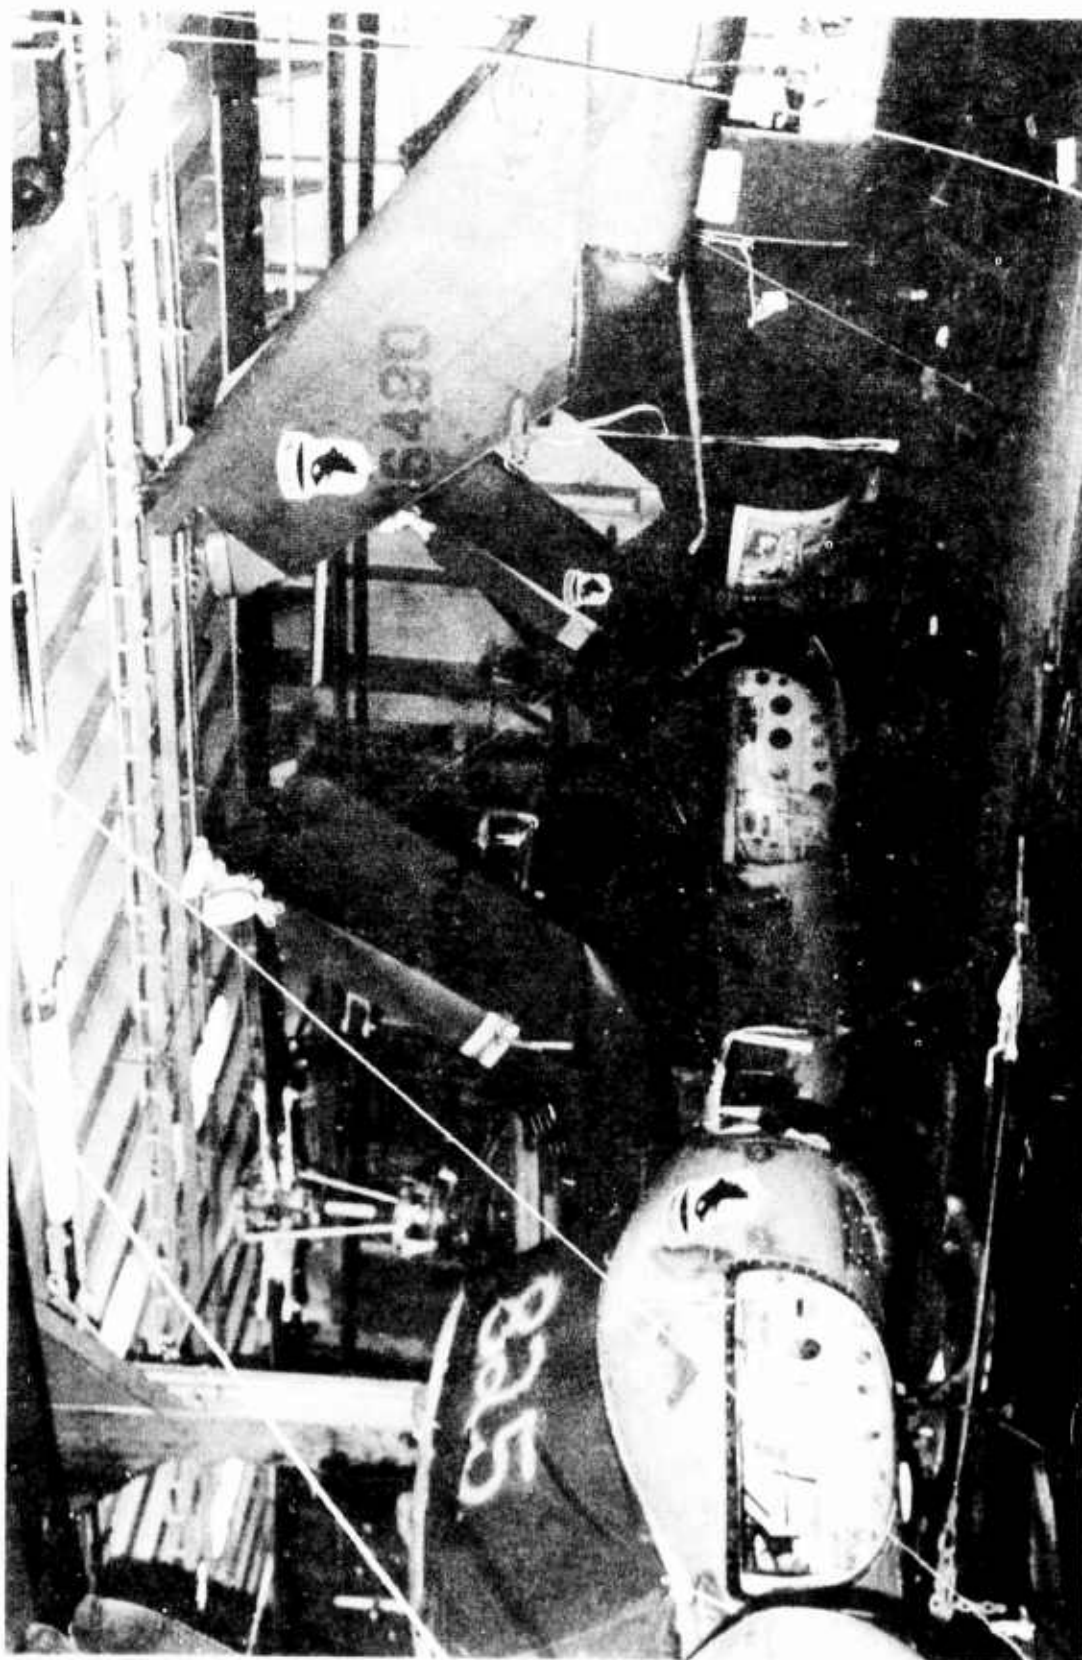
Figure 8-10. Tight UH-1 Stow.

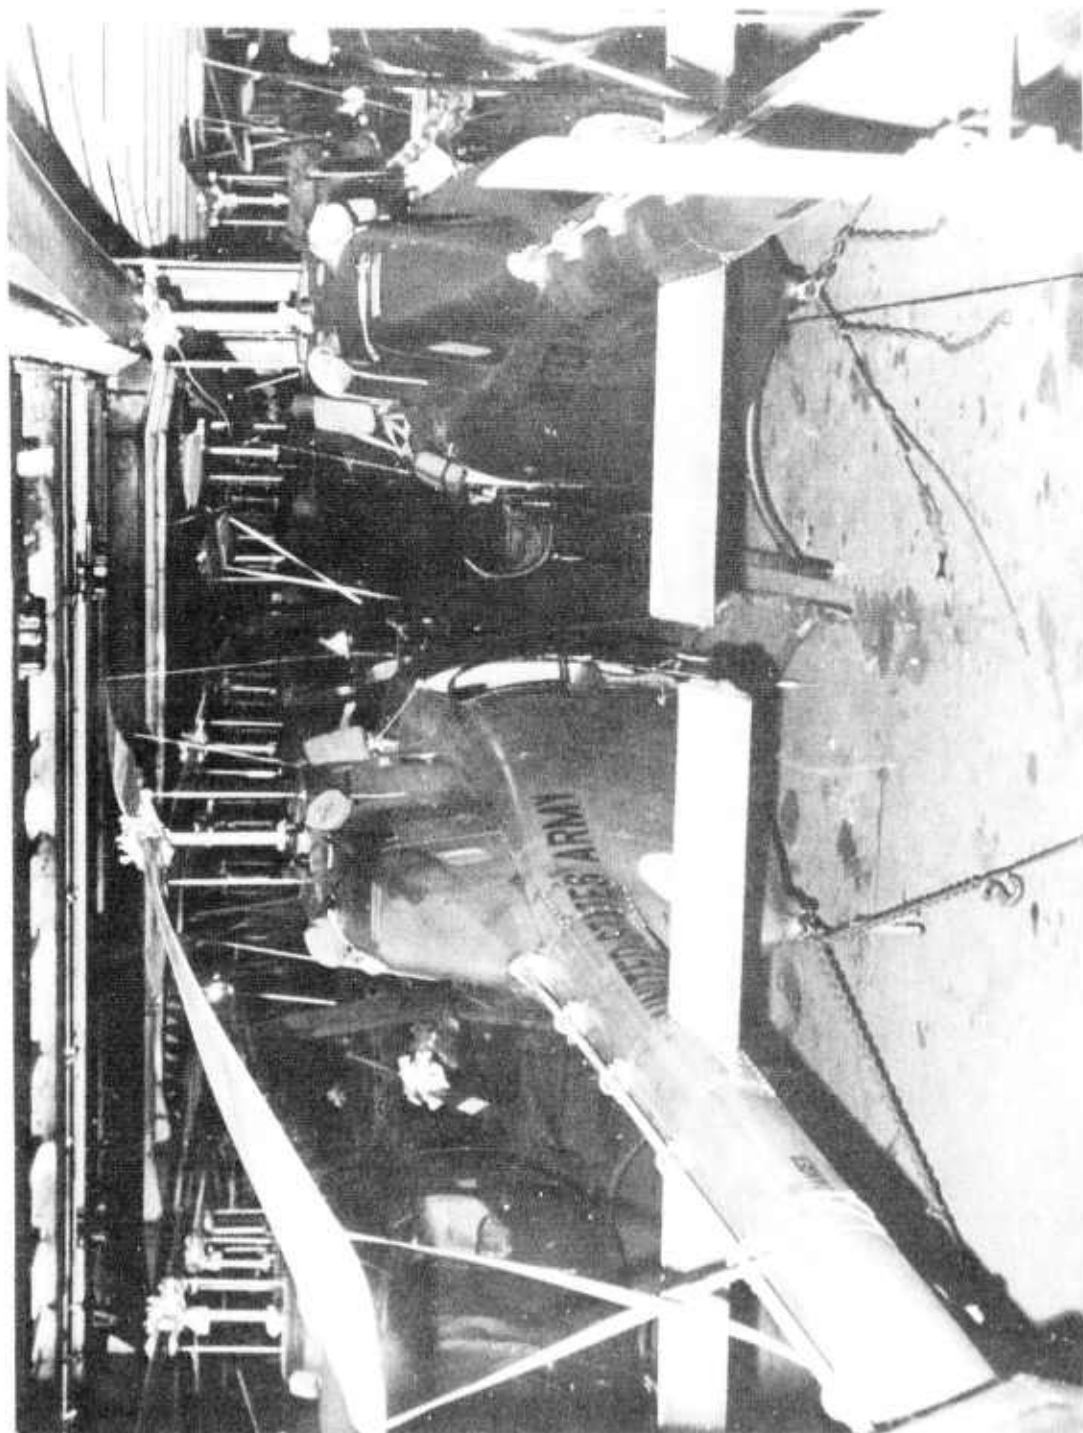
Figure 8-11. Below Deck Stow of OH-58 Helicopters With Rotor Blades Installed.

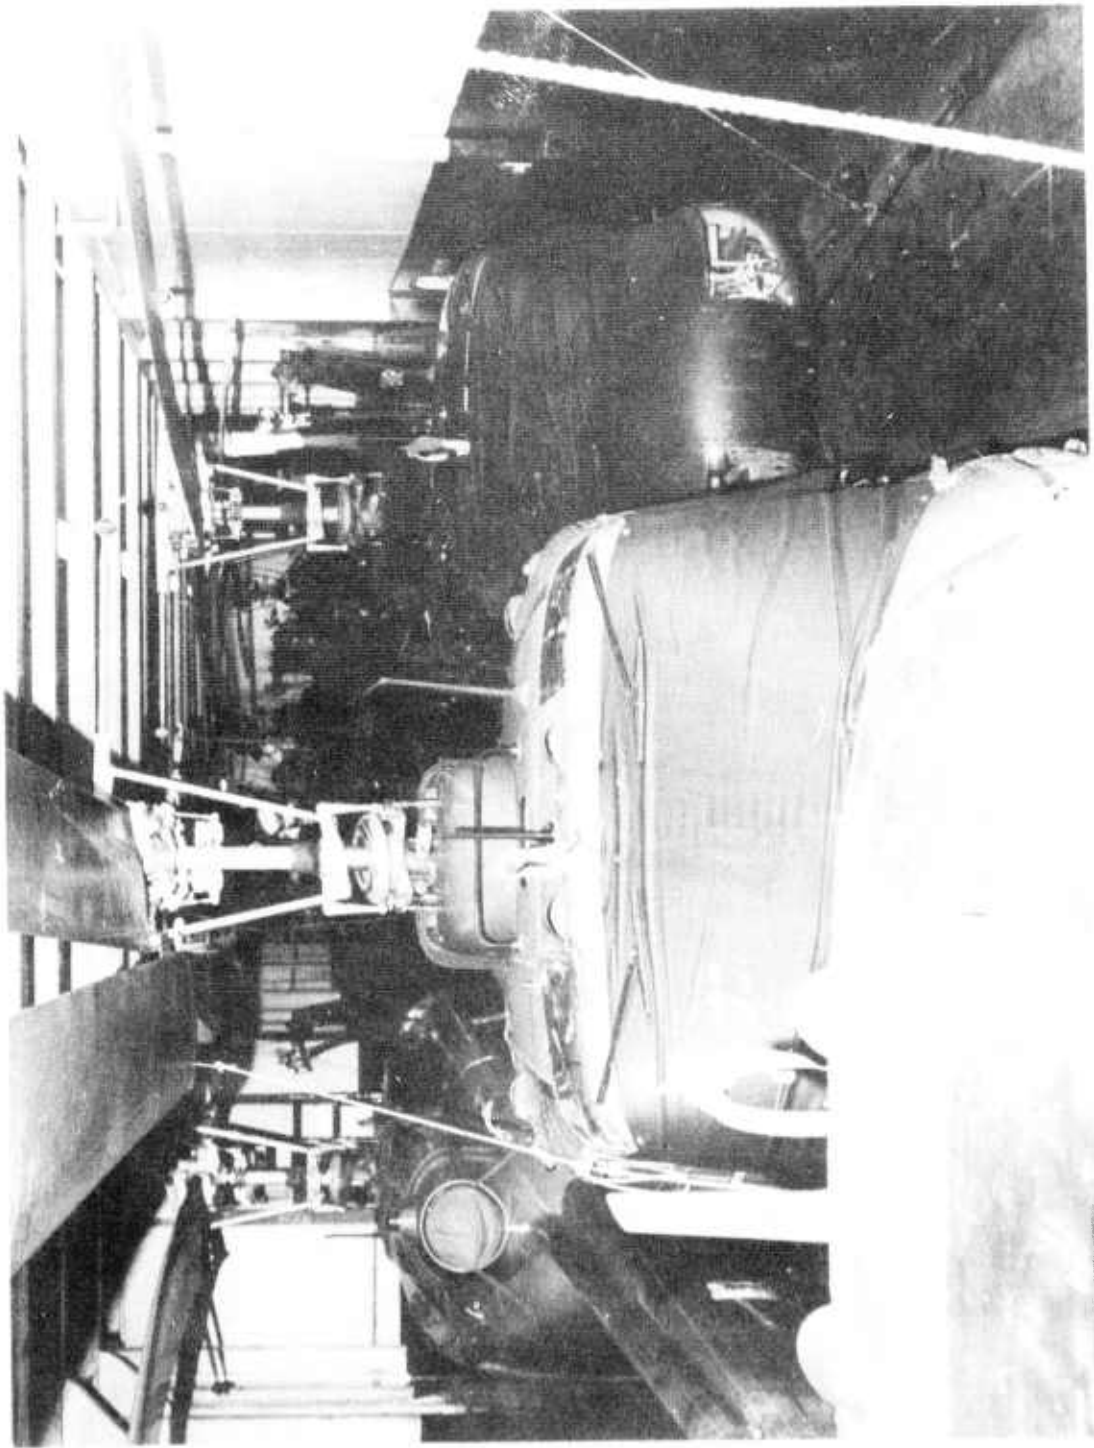
Figure 8-12. Below Deck Stow of UH-1 Helicopters With Rotor Blades Installed.

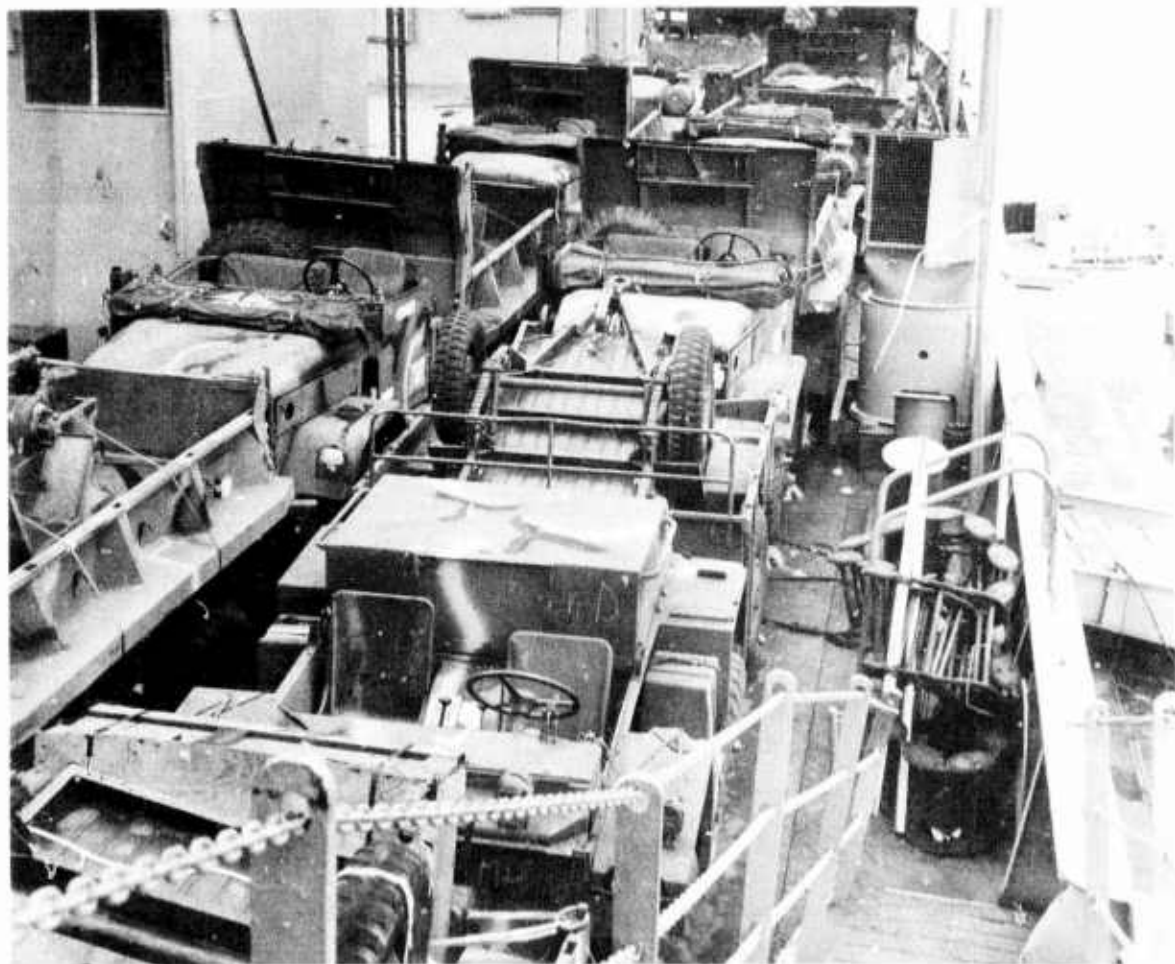
Figure 8-37. Typical Tight Stow of Vehicles on Comet.

(1) A very tight stow was necessary on all four vessels (Figures 8-37 to 8-40). Normal RORO loading was modified by using forklifts and stevedore personnel to lift and push vehicles into spaces impossible to drive into. All tiedowns were doublechecked to insure a stable, damage-free ocean voyage (Figure 8-41).

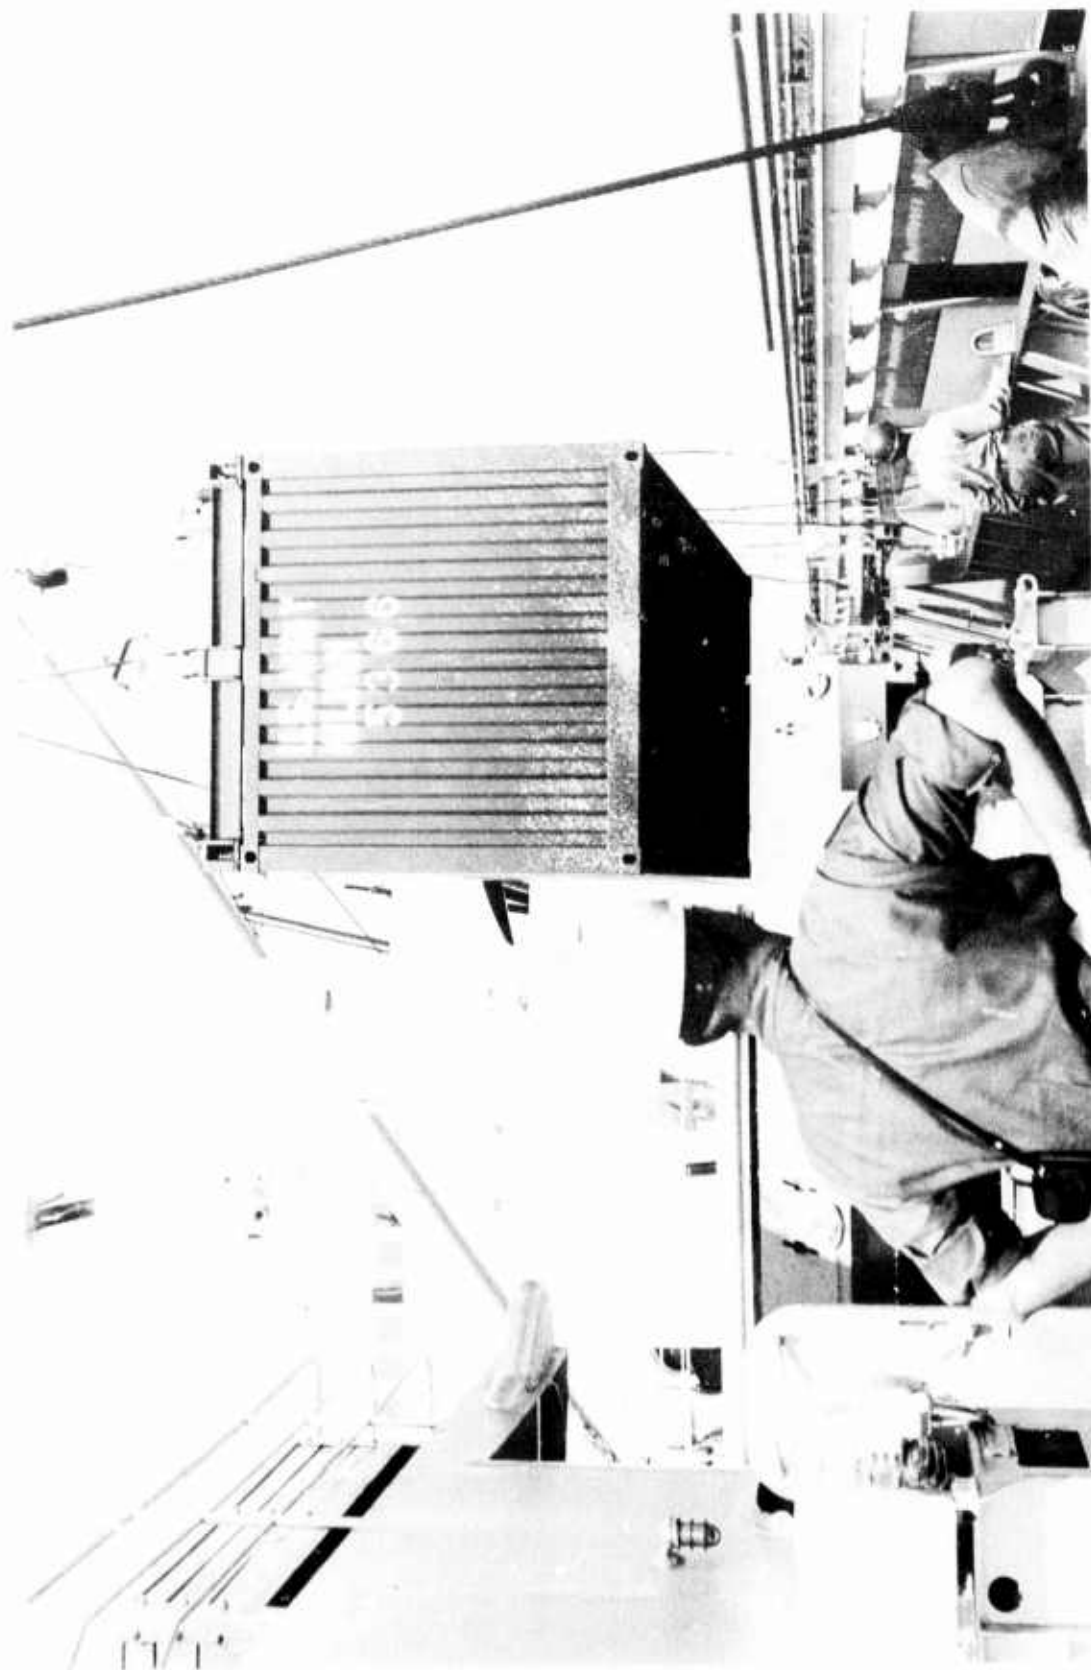
Figure 8-50. MILVAN Loaded on American Ranger Using the Manually Locked Container Top Lifting Device.

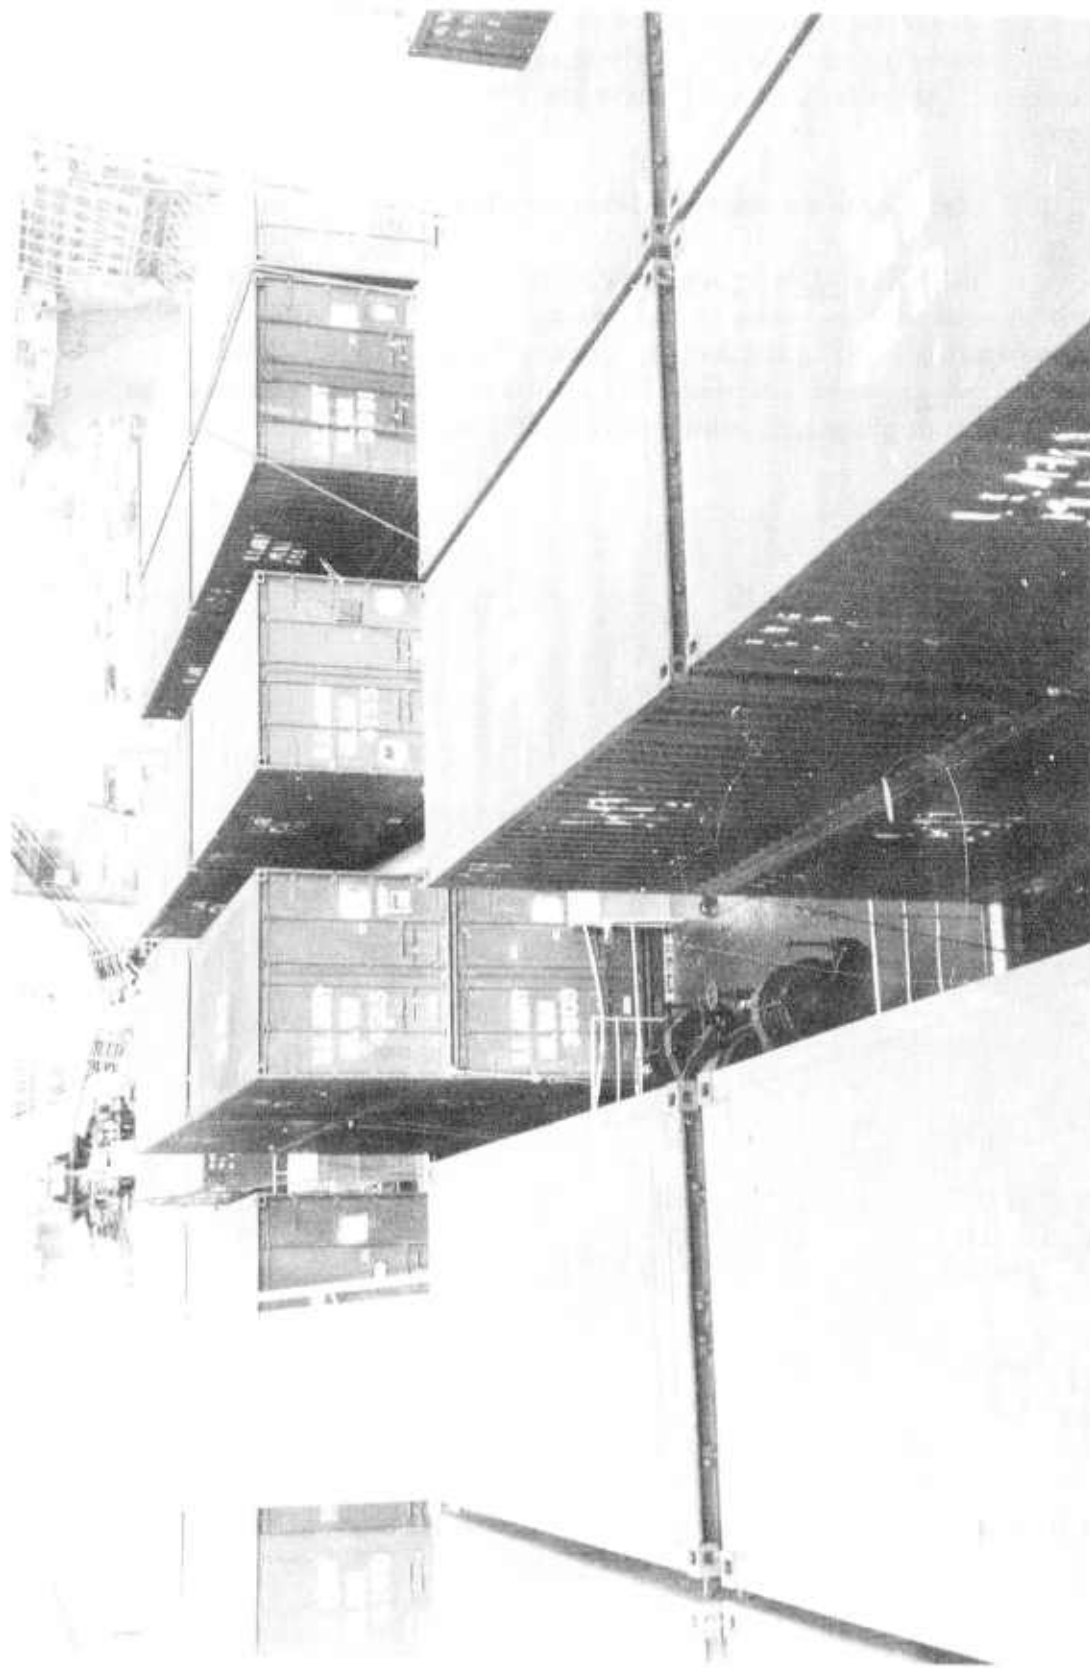
Figure 8-52. MILVANs Stowed Three High on Deck USS American Ranger.

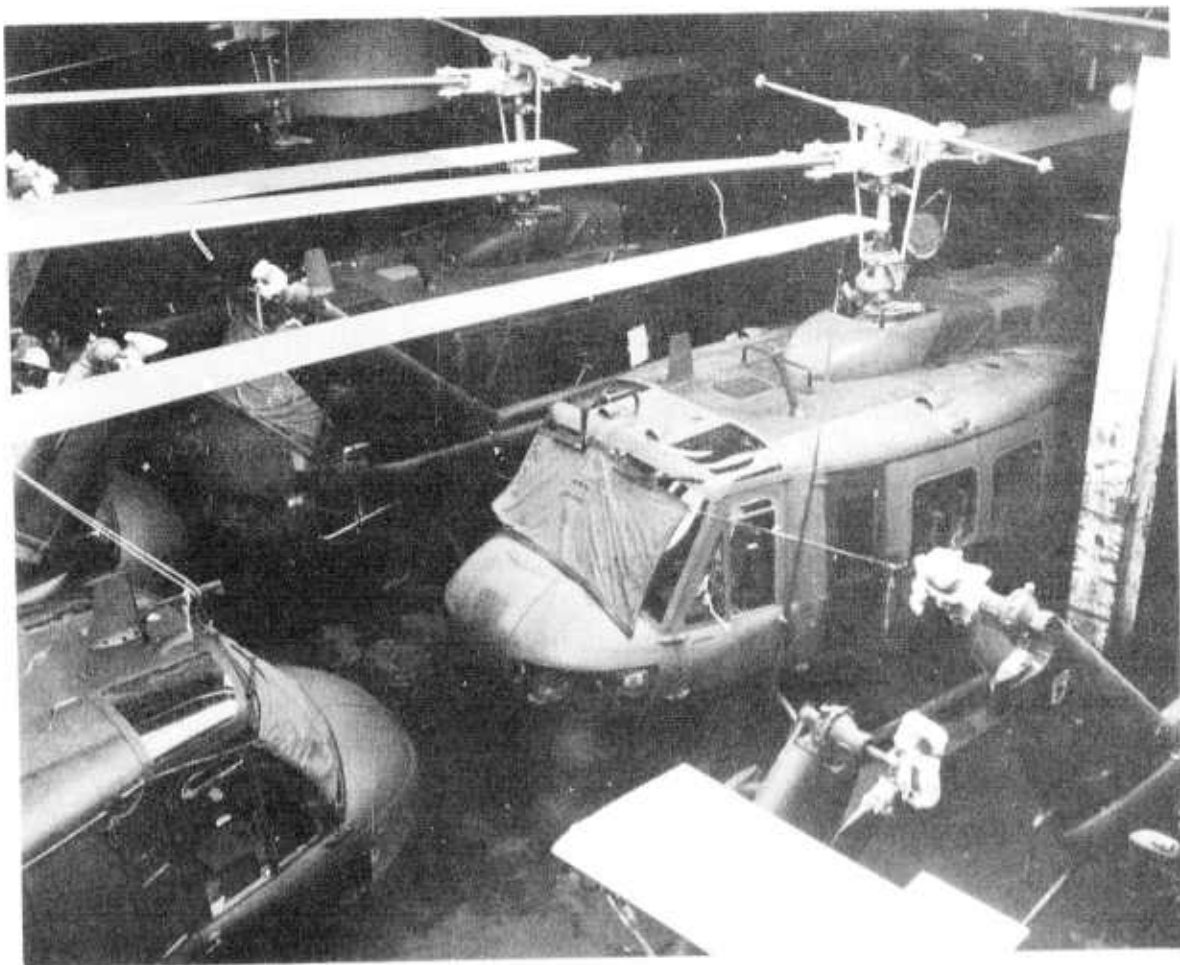
Figure 8-63. UH-1 Helicopter Stowed in Hatch Square (GTS Callaghan).

(l) Stowing UH-1 and AH-1 helicopters with rotor blades in the square of the hatch proved to be time-consuming (Figure 8-63). To facilitate loading and discharge operations, these helicopters had their rotor blades removed during redeployment loading operations.

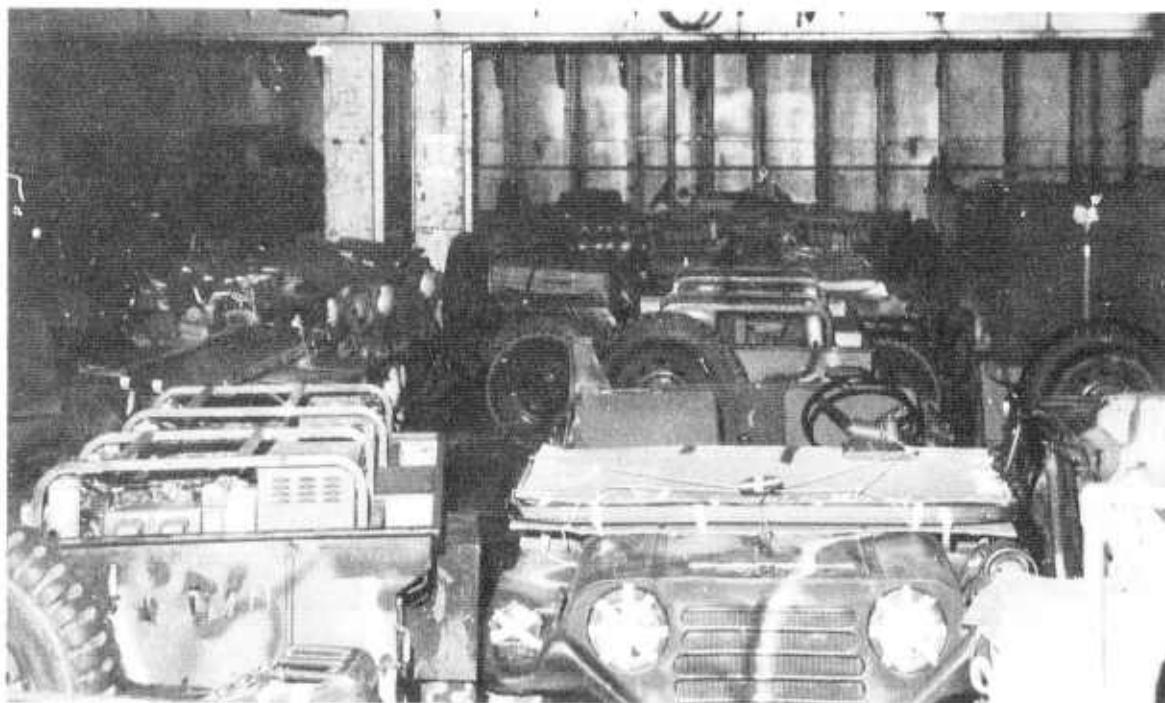
Figure 8-66. Forklift Placing Vehicle in Final Stow Position.

(5) The tight stow of vehicles restricted immediate drive-off access on the RORO vessels. Some vehicles had to be moved into position for drive-off discharge (Figures 8-66 through 8-69). When a tight stow is used on RORO vessels, SPOD stevedore gangs should be notified in advance so that appropriate special equipment (forklifts and tow tractors) will be on hand.

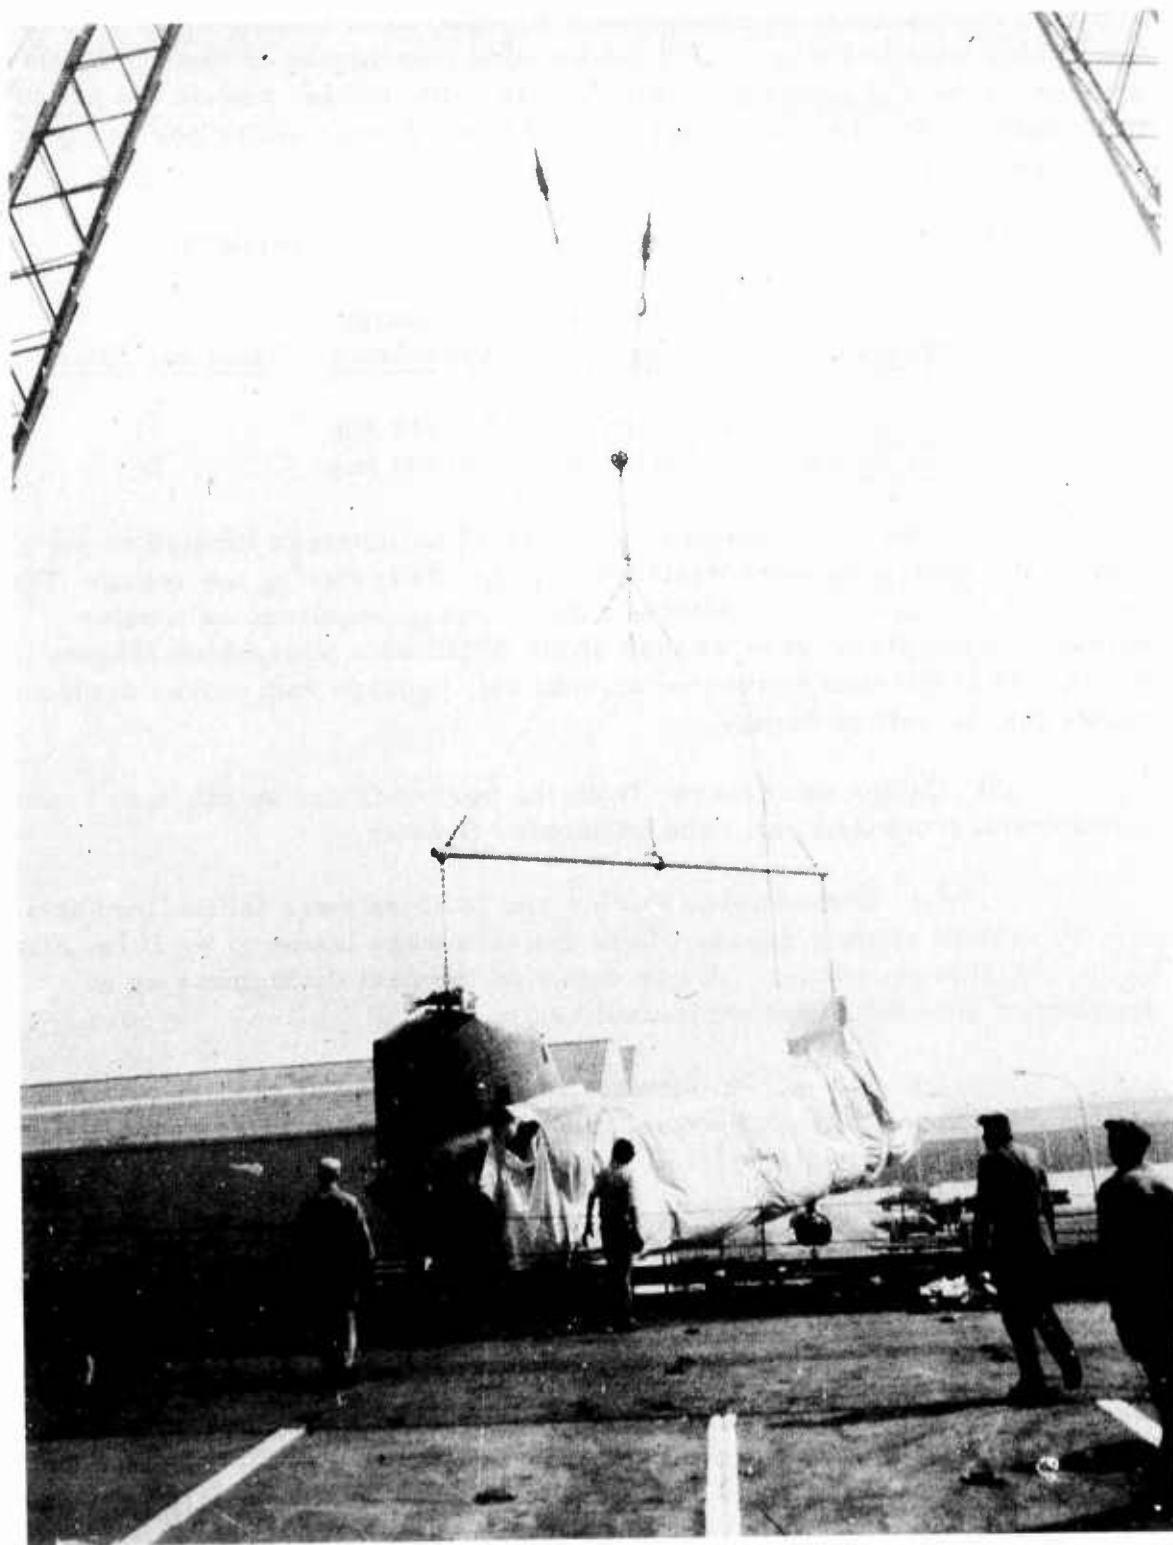
Figure 8-72. Unloading CH-47 With "Yo-Yo" Sling at Ghent, Belgium.

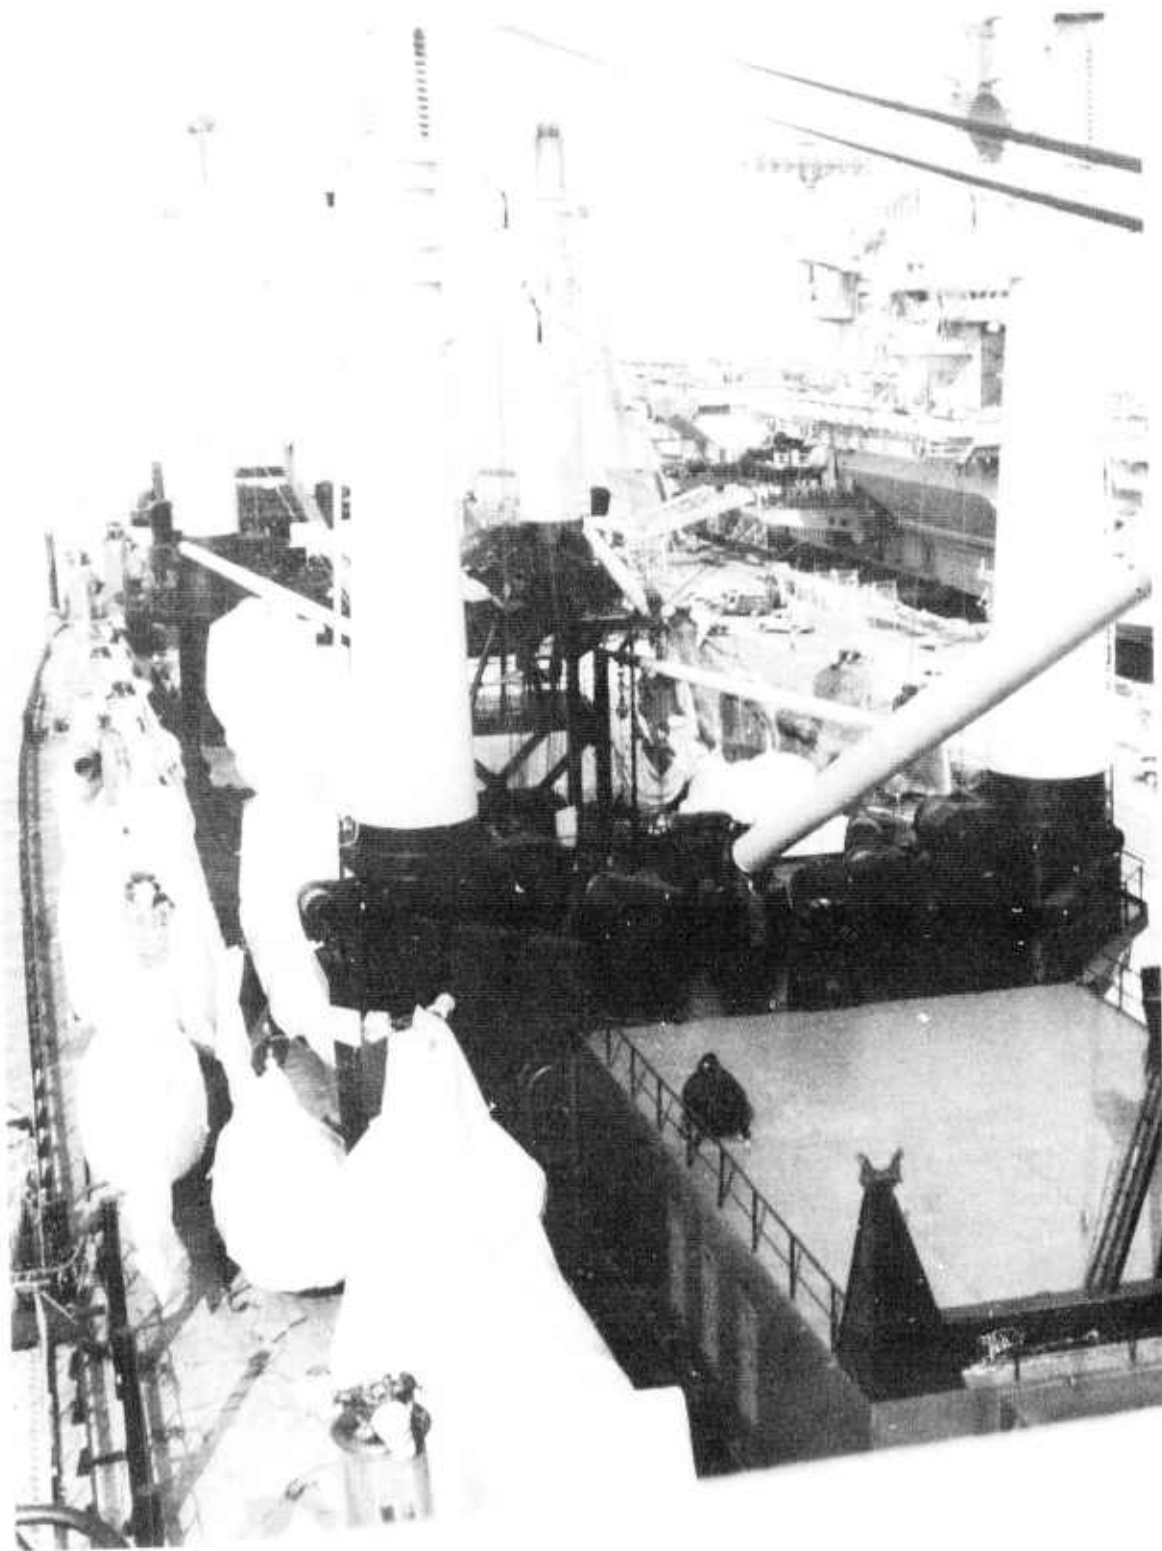
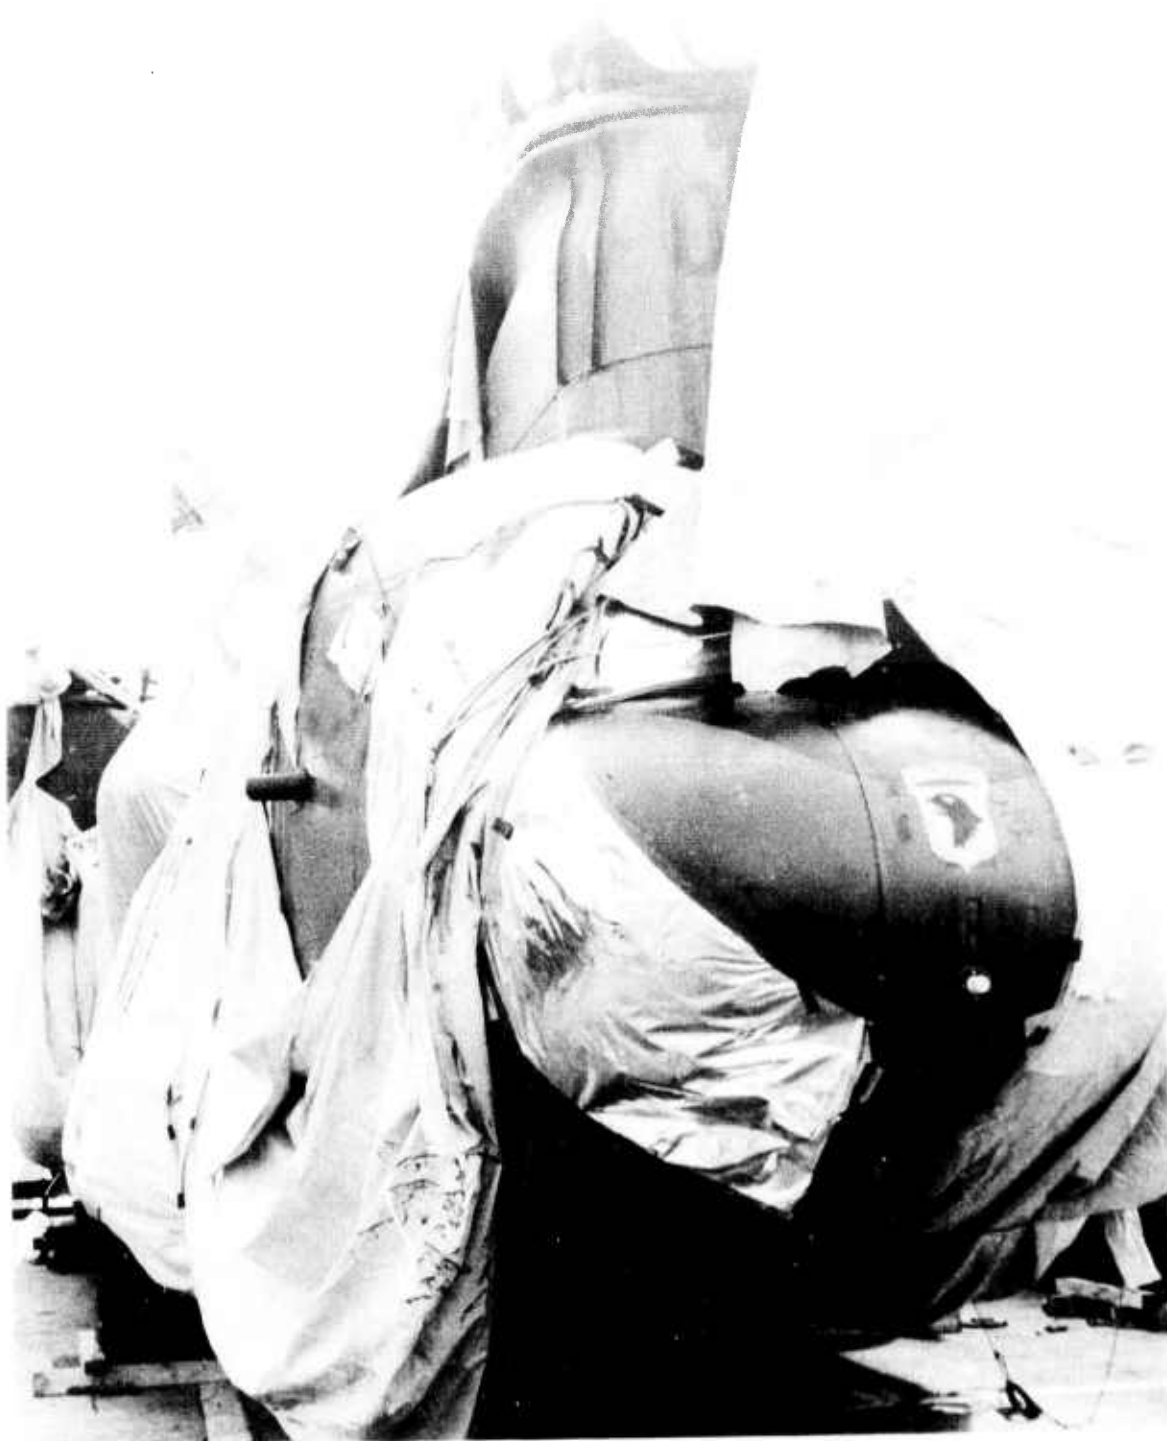
Figure 8-73. Damaged CH-47 Redi-Covers.

Figure 8-74. Damaged CH-47 Redi-Covers.

Figure 8-75. Damaged CH-47 Redi-Covers.

Figure 8-76. Damaged CH-47 Redi-Covers

(d) The zippers on the helicopter redi-covers provided by AVSCOM came open while subjected to normal winds, and modifications were recommended.

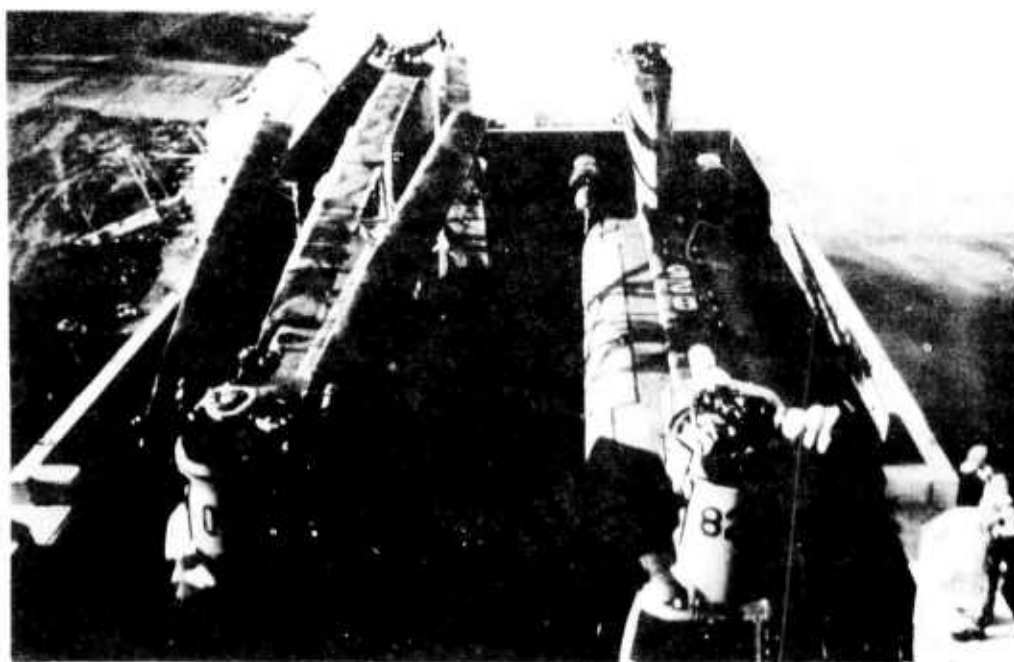
Figure B-4. CH-47 Helicopters in a LASH Lighter.
